HAZARD RANKING SYSTEM (HRS) DOCUMENTATION RECORD - REVIEW COVER SHEET

Name of Site: MacMillan Ring Free Oil

HRS DOCUMENTATION RECORD

Date Prepared: December 2013

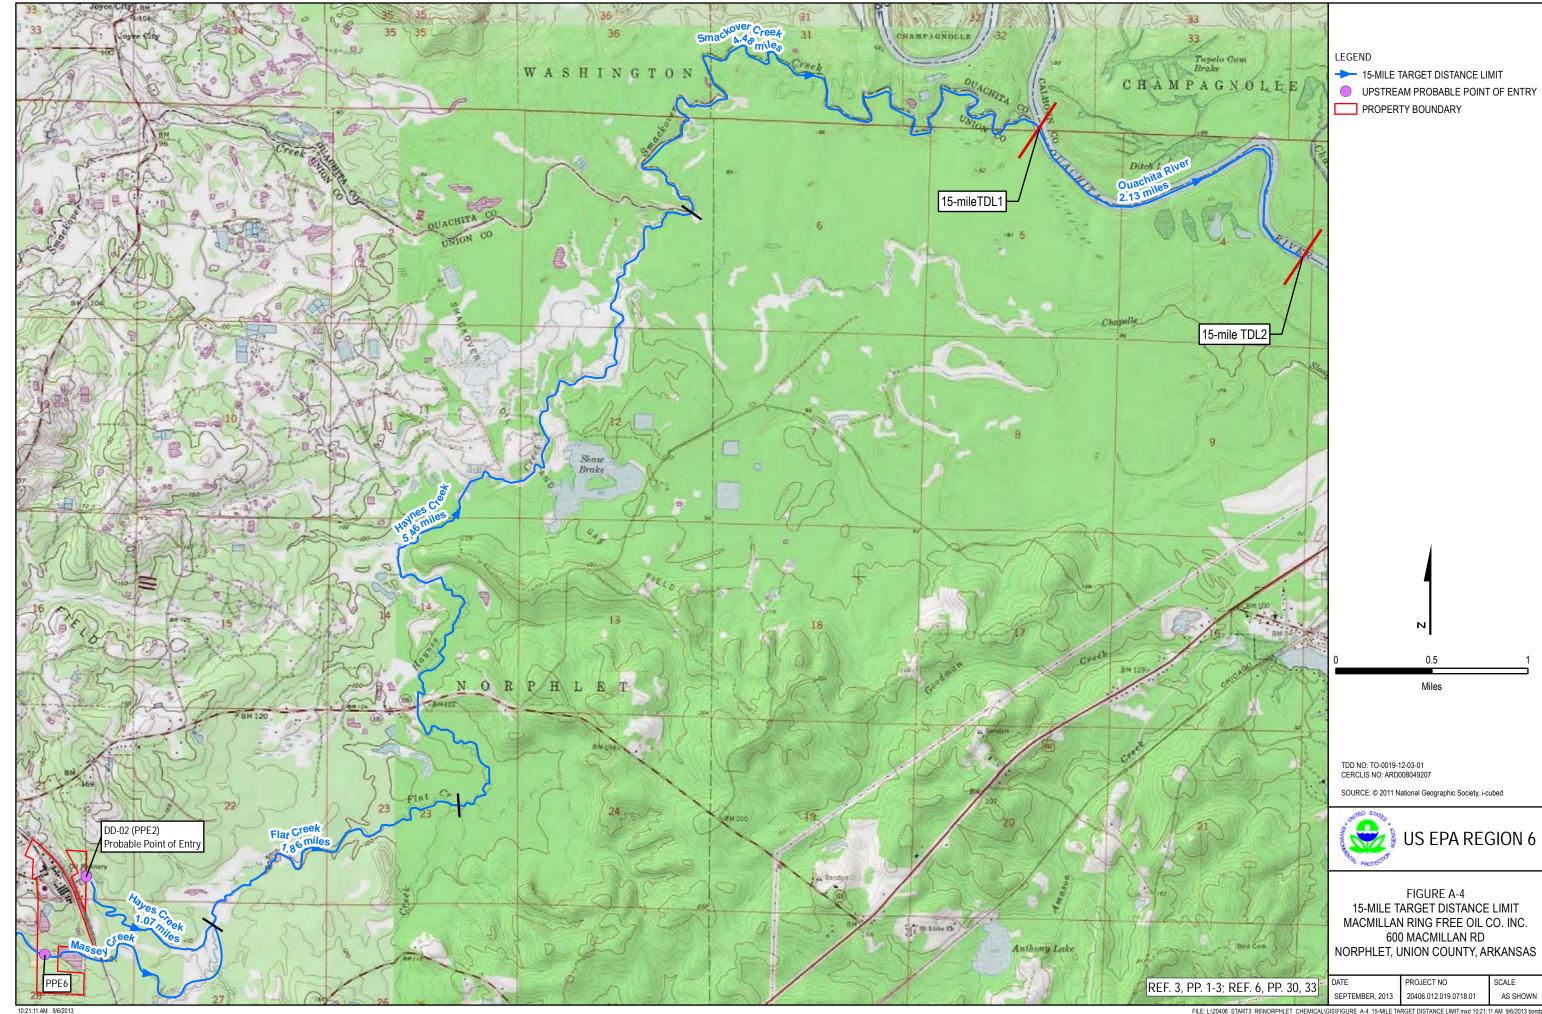
The hazardous substance migration path includes both the overland and the in-water segment that hazardous substances would take as they migrate away from sources at the site (Ref. 1, S ection 4.1.1.1). Hazardous substance migration paths overland and in-water segments for Sources 1 through 5 are described in the following text. The surface water pathway is presented on Figures A-3 and A-4.

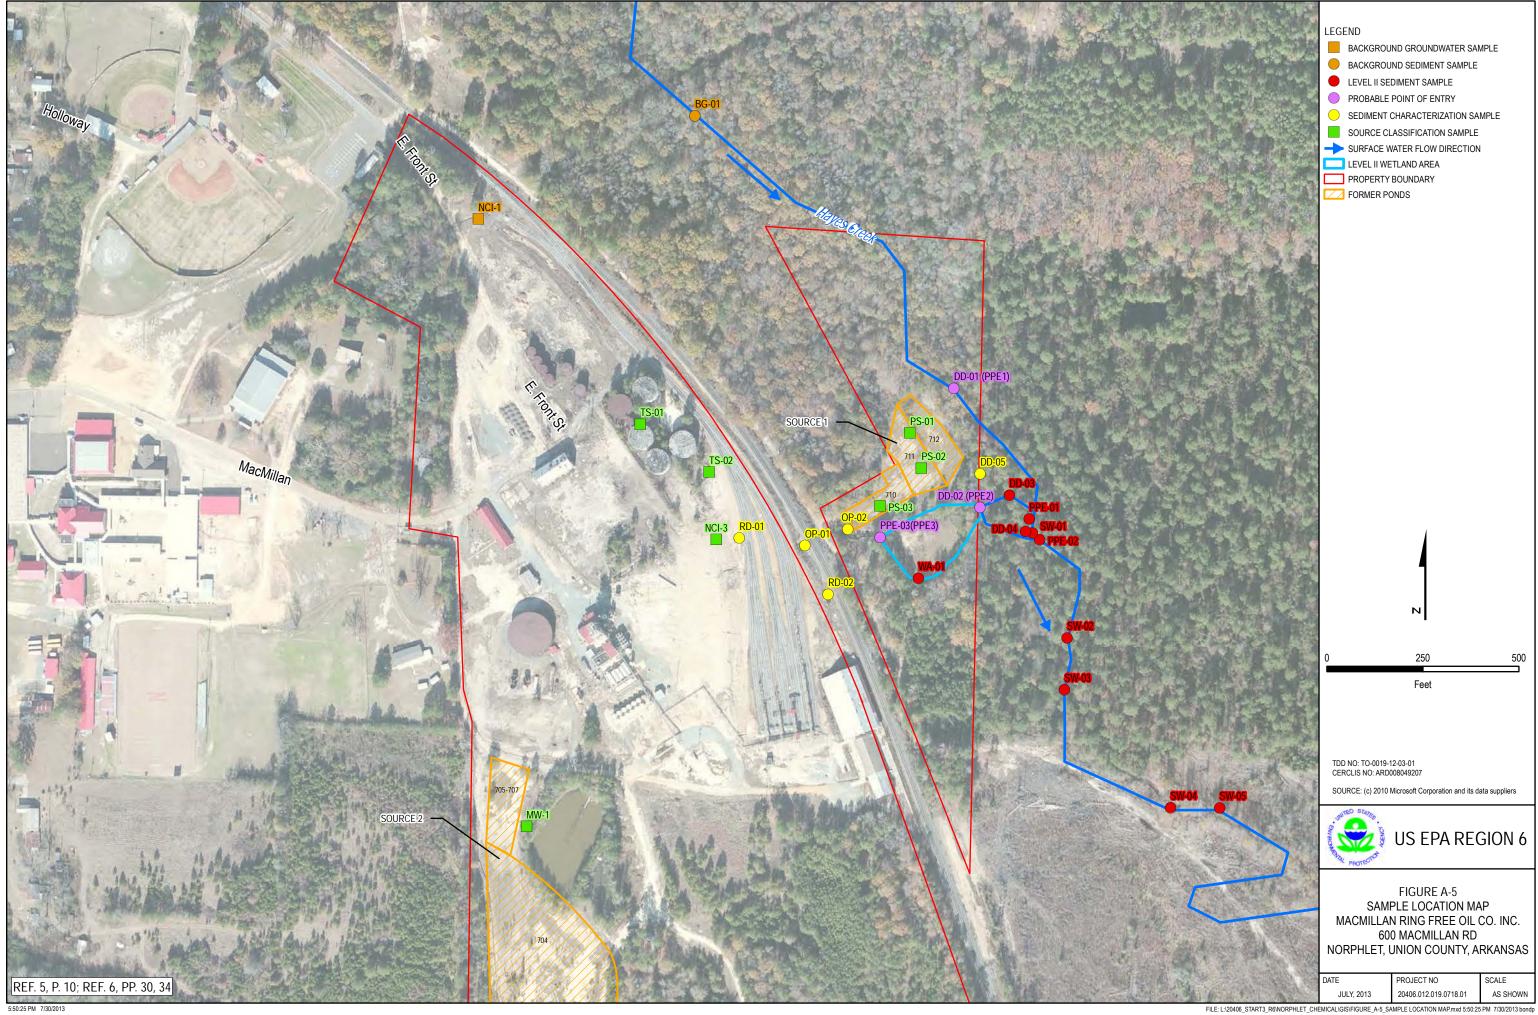
During the August 2012 SR sampling activities conducted by EPA contractors, surface water and sediment samples collected from within the surface water pathway demonstrated elevated concentrations of hazardous substances (Ref. 5, p. 4). For the purpose of this report, only the sediment samples are being presented, as the sediment samples alone provide sufficient evidence to establish an observed release. Two sediment samples were collected from the wetland contiguous to Hayes Creek and twelve sediment samples were collected from within Hayes Creek (Ref. 5, p. 4). Sample locations are depicted in Figure A-5 of Attachment A.

A background sediment sample was collected from Hayes Creek (BG-01) approximately 1,000 feet upstream and upgradient of the site (Attachment A, Figure A-5; Ref. 25, p. 4). The background sediment sample collected from Hayes Creek is compared to site-related sediment samples collected from the wetland contiguous to Hayes Creek and Hayes Creek in order to illustrate an observed release from the site to the surface water pathway can be established (Ref. 5, p. 4; Ref. 25, pp. 13, 21).
